Steam Schooner
WAPAMA
HISTORIC STRUCTURE REPORT
1986

Steam Schooner
WAPAMA
HISTORIC STRUCTURE REPORT

**The National Maritime Museum at San Francisco
The National Park Service,
Golden Gate National Recreation Area
Fort Mason, Building 201
San Francisco, California, 94123**

**Tri-Coastal Marine, Inc.
(White Elephant Management)
2104 Strand, Galveston, Texas, 77550**

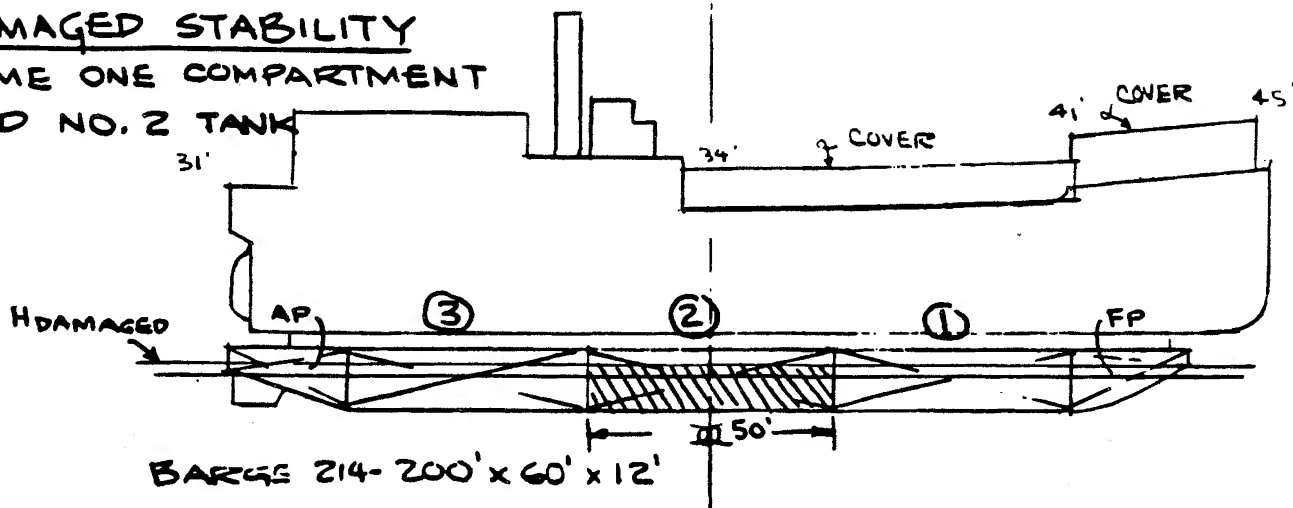
ASSUME ONE COMPARTMENT

FLOOD NO. 2 TANK

BARGE 214-200' x 60' x 12'

H INTACT = 5.65 ft
